TITLE: Industrial Case Histories

TITLE: New Frontiers in Integrated Diagnostics and Prognostics.  
Proceedings of the 55th Meeting of the Society for Machinery Failure  
Prevention Technology. Virginia Beach, Virginia, April 2 - 5, 2001

## **Industrial Case Histories**

**Kevin R. Guy**

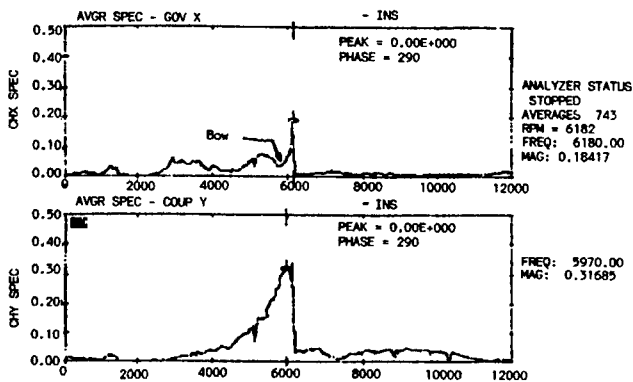
Figure #4

**Corrective Action:** Since the second balance plane (exhaust end) was closer to the mid span and we were trying to balance a first mode it was decided to place weights in this ring. Also, since this ring was closer to bearing #2 and the highest vibration was on bearing #1 a two plane balance program was entered. The unit was successfully balanced below the first critical; however, the unit again tripped at the second critical. A second two plane balance program was started below the second critical. During the balancing at the second critical two other problems developed. The unit suffered a rub and a bow was detected in the coastdown data (figures #4 & #5). The rub was not initially detected and several balance runs were lost to the rubbing.

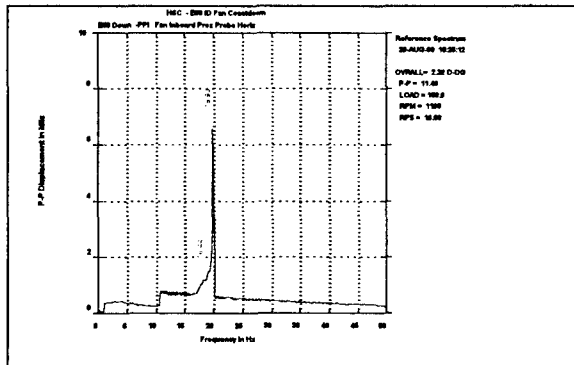
Figure #8

Phase and amplitude data showed thermal vectors as high as 6.8 mils (Figure #7). Coastdown data indicated the vibration dropped off almost immediately as the power was cut (Figure #8). This is a definite indication the fan is running very close to a natural frequency. In 52.5 cycles, the shaft vibration drops by over 76%

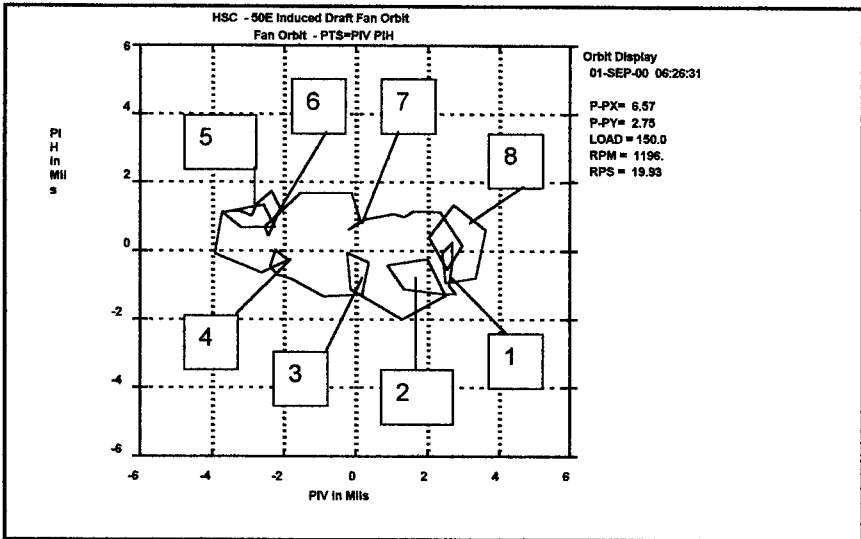
Figure #10

The internal loops indicate a forward whirl of the shaft. The frequency of the vibration is found from the following formula:

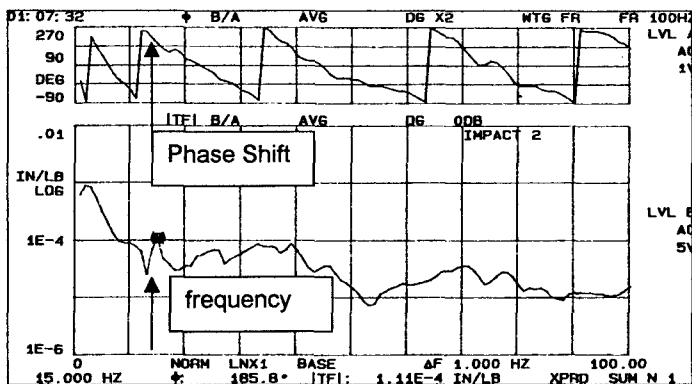
Figure #14

The Shaker tests indicated distinct natural frequencies around blade pass Figure #13). The amplification (Q Factor) from the tests were from 5.3 to 10.5 plus. Impact test (Figure # 14) and Shaker Test results can be found in Table III.

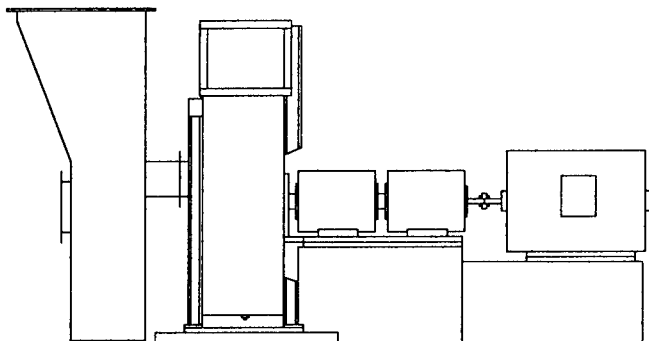
Figure #16

**Problem:** This plant has had a history of recurrent vibration problems on their primary air fans. Looseness problems show up several times per year. The fan is an overhung design (figure #16). The replacement of the straight bore babbitt bearings is followed by a balancing of the fan using seismic readings. The fan is easily balanced below 1.0 mils (pk-pk). However; the vibration is always back into alarm with in a few weeks.

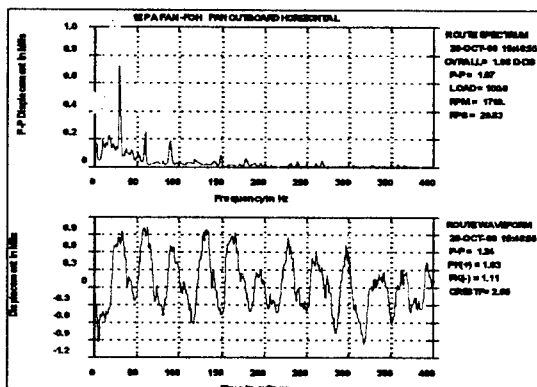
Figure #19

The fan was balanced with seismic sensors. This has been the balancing procedure since the fan was put in operation in the early 1980's. The fan was balanced in one shot using past sensitivities and lag angles. Vibration levels were below .80 mils (pk-pk) at operating speed (Figure #19).

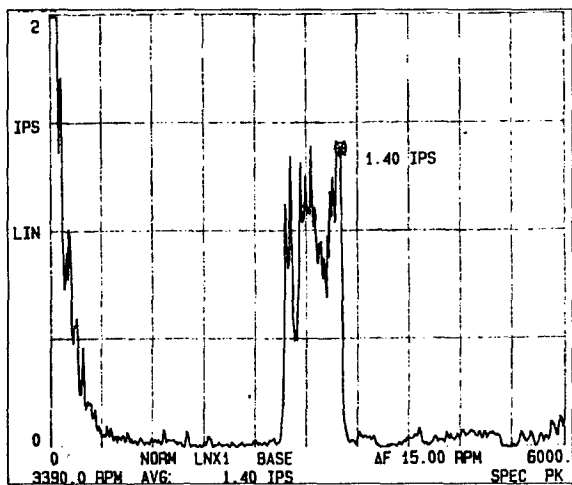
**Test Data and Observations:** The initial request was to find if the unit could be relied upon for load sales the next day. Vibration data collected on the turbine indicated a ratty vibration spectrum with most of the vibration below running speed. Figure #22 shows the outboard pump bearing with over 1.40 in/sec of vibration at 3390 cpm. The inboard pump bearing had high vibration (>.75 in/sec) at 2900 cpm. This data indicate two possible problems. First the 3390 cpm frequency was a problem caused by rubbing of the rotating and stationary balance components of the pump. This was determined from past documented data on boiler feed pump vibration problems. Second, the spectrum from the inboard end of the pump indicated a frequency that was too low to be a rubbing problem in the pump.

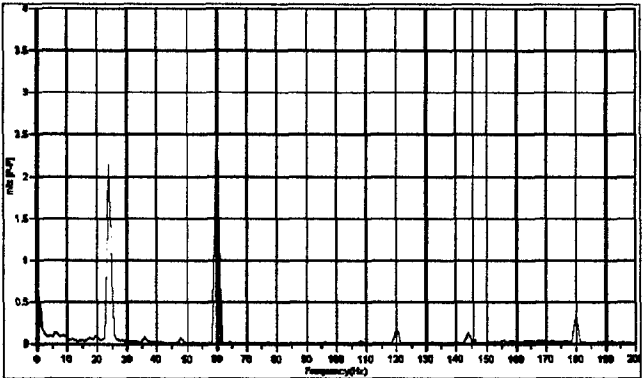
Figure #24

The data indicated the vibration was all subsynchronous (Figure #24). An oil whip problem was detected during the over speed testing of the unit (Figure #25); however, this was only present during the running of the over speed tests. During the over speed testing; the subsynchronous vibration was locked on 24.75 Hz

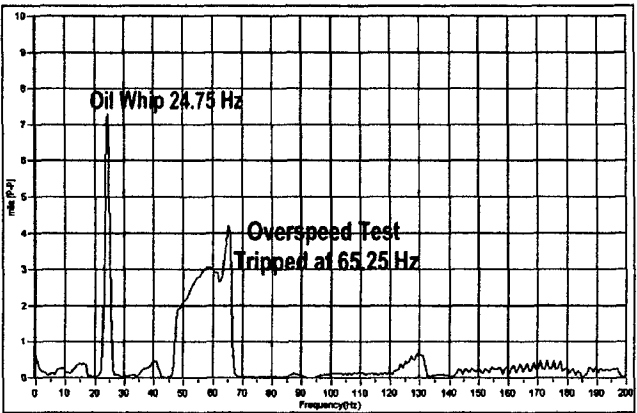
Figure #25

(1485 cpm) and appeared instantaneously. The onset of this whip during overspeed testing was at a shaft speed of 3510 rpm (58.5 Hz).

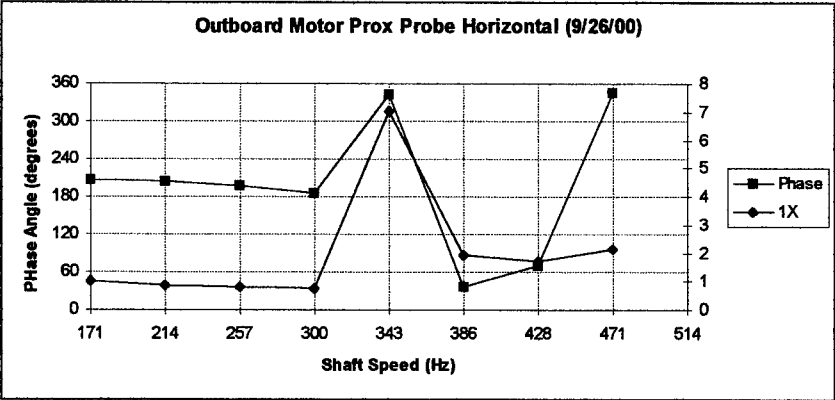
Figure #32

Balancing was able to somewhat lower the vibration in the uncoupled condition; however, when coupled up the vibration was still high at 40 Hz excitation and would trip the motor. There was also a thermal effect noted in the balancing process. During the step by step progression of collecting data at several points as the motor excitation was increased a poor mans bode plot was constructed (Figure #32). This data is from the outboard motor horizontal proximity probe.

The increase in vibration at 343 rpm (39 Hz excitation) with the associated phase shift is showing the shaft is going through a critical speed.

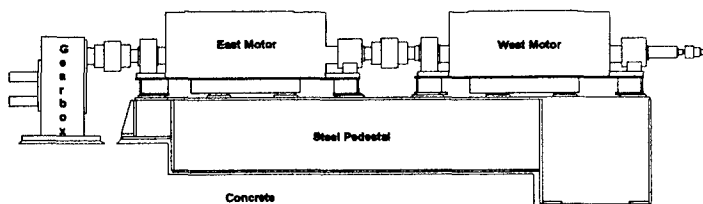
Figure #39

**Problem:** Immediate problems were suffered during the initial running of two new DC motors. The motors were a retrofit of older drive motors on an aluminum rolling mill. The new motors (two motors in series – Figure #39) were supplied by General Electric with a maximum operating speed of 1500 rpm. The motors are a complete retrofit including the motor frame and pedestal. It should be noted the steel pedestal for the system is hollow. A sister installation of this system is installed in another plant and operating without vibration problems throughout the speed range.

The only difference between the motors in this plant and the sister plant; is the problem motors utilize rolling element bearings. The sister plant is using straight bore babbitt sleeve bearings while the problem motors were retrofitted with rolling element bearings against the manufactures recommendations.

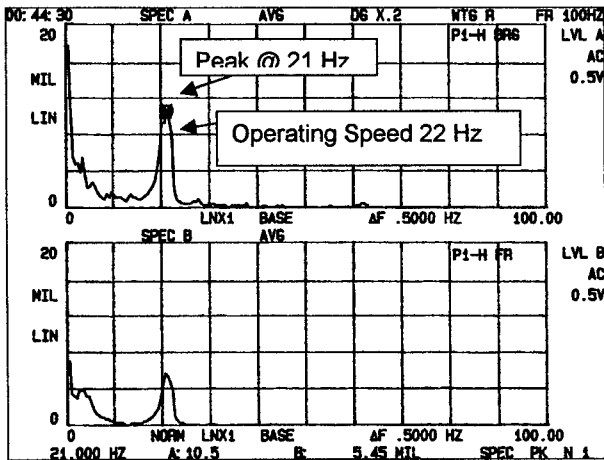
Figure #40

**Symptoms:** The motors were still not in operation; however, during trial runs high vibration amplitudes were found on the west motor while running around full rolling mill speed, 1260 rpm (21 Hz). While there was vibration on the east motor the amplitudes were acceptable. During the setup of equipment for testing the motor accidentally turned on and went up to just above operating speed (Figure #40). This data indicated the vibration increases suddenly when the motor speed is at the top end of the operating range.

The operating speed reached 22.0 Hz with the peak vibration at 21.0 Hz.

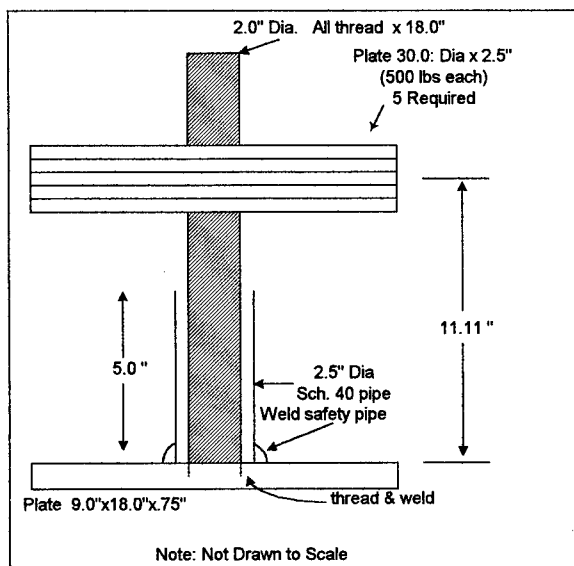
Figure #42

The design of the DVA dictates that it must be at least 10% of the total weight of the machine. The west motor, frame and pedestal weighted roughly 25,000 pounds. This means the absorber must have at least 2500 pounds of weight. To design an absorber one has to determine the length of the vertical support based on the weight to be supported (Figure #42).

**Corrective Action:** The idea behind a Dynamic Vibration Absorber (DVA) is to have the absorber vibrate instead of the equipment. The dynamic absorber is designed to have the same natural frequency as the offending machine. This equipment train would require a DVA to have a natural frequency around 22.0 Hz. This would then absorb the vibration energy and allow the machine to run normal vibration amplitudes. Since the west motor had the highest vibration amplitudes, the absorber would be designed for this motor.

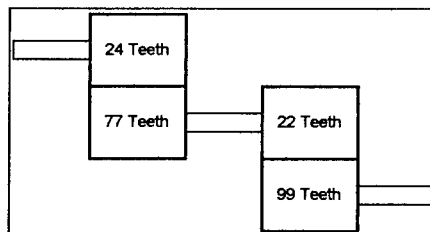
**Symptoms:** During the equipment baseline check out and acceptance process high vibration was experienced on the input shaft of the gearbox in the horizontal direction. Vibration amplitudes of over .60 in/sec 0-pk were documented. The plant had set overall alarm settings of .10 in/sec 0-pk. The vibration appeared to occur in only one area of the speed range. Figure #43 is a schematic of the gearbox layout.

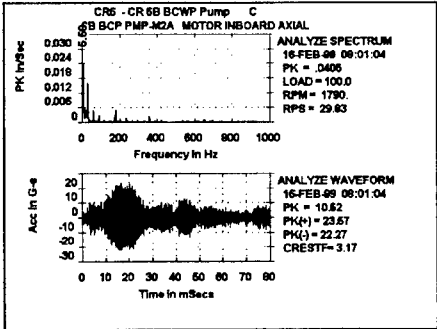
Figure #50

This data was collected with 400 lines of resolution with an Fmax of 5000 Hz. The resolution for this plot is 37.50 Hz per bin. Because of the bin width, frequency identification would be difficult. Timewave data shows peak acceleration at 23. 57 g's. Looking at the same data on a smaller frequency range shows the 1X vibration along with a frequency at 5.58 Hz (Figure #50). A walk down of the unit revealed a high pitch squeal around the pump. The motor pump train operates at 29.58 Hz with radial bearings in the motor, top, and bottom of the pump. Below the upper pump bearing are two thrust bearings.

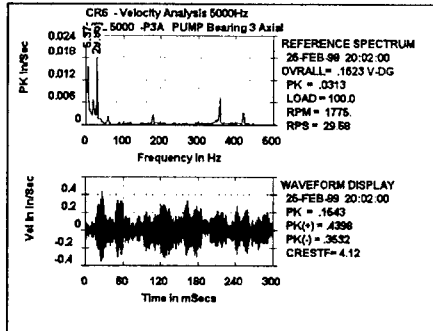
Figure #53

The new plots with the longer time data shows the bursts of energy are at 1X (Figure #52). Looking at the same point in Velocity (Figure #53) shows essentially the same information as figure #2; 1X and a subsynchronous vibration between 5.0 and 6.0 hertz. None of the velocity or Acceleration plots indicate any bearing frequencies. The time data is typical of bearing frequencies; however, no distinct frequencies can be identified. Since the goal of this analysis was to identify if the problem was a pump or motor bearing it was decided to try peak view analysis. The peak view data plots showed two distinct bearing problems on the thrust bearing in the pump (Figure #54).
